Manhole Inspection Summary

Manhole # S69O__006MH

Insp Date: **2/6/08 9:57 AM**

Location Address: **6600 Boston Ave.**

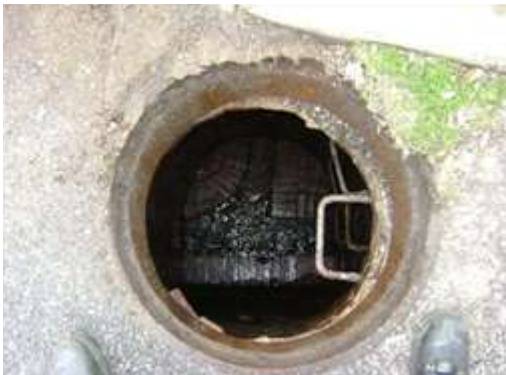
Defect 1

Offset: **1** (in.)

1 in. frame offset

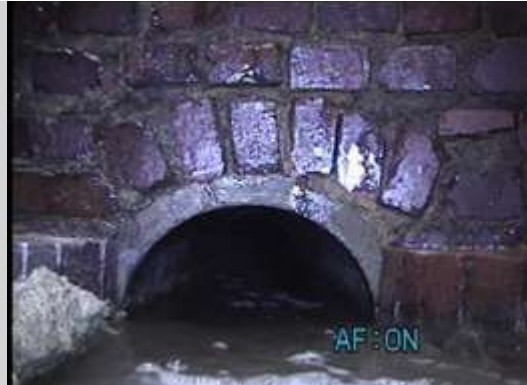
12 O'Clock Outflow

12 in. Circular Gravity Sewer
Pipe Out @ 12 O'Clock

Pipe Height: **12** (in.) Rod and Bar (Angled)
Pipe Material: **Clay** ☐ Pipe Lined
Invert Depth: **12.00** (ft.) Flow Characteristics: **Fast**
Deposits: ☒ None ☐ Mud ☐ Sludge ☐ Debris ☐ Grease
Silt Depth: (in.) Deposits Extent:
Infiltration: **None** Pipe Seal Cond: **Sound**

Drop: **None**

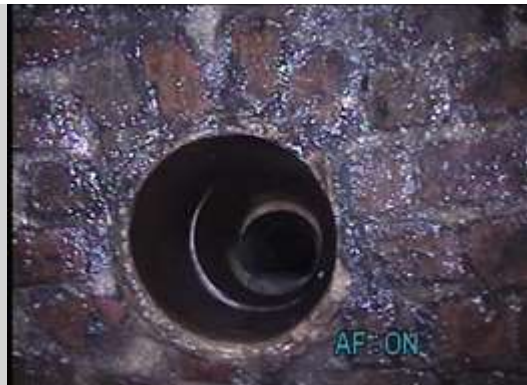
3 O'Clock Inflow

8 in. Circular Gravity Sewer
Pipe In @ 3 O'Clock

Drop In @ 3 O'Clock

Pipe Height: **8.4** (in.) Rod and Bar (Angled)
Pipe Material: **Clay** ☐ Pipe Lined
Invert Depth: **7.33** (ft.) Flow Characteristics: **Fast**
Deposits: ☒ None ☐ Mud ☐ Sludge ☐ Debris ☐ Grease
Silt Depth: (in.) Deposits Extent:
Infiltration: **None** Pipe Seal Cond: **Sound**

Drop: **Outside** Rod and Bar
Angled: **Yes** Reading: **10.75** (ft.)
Inv Depth: **11.75** (ft.)

Drop Condition: **Open**

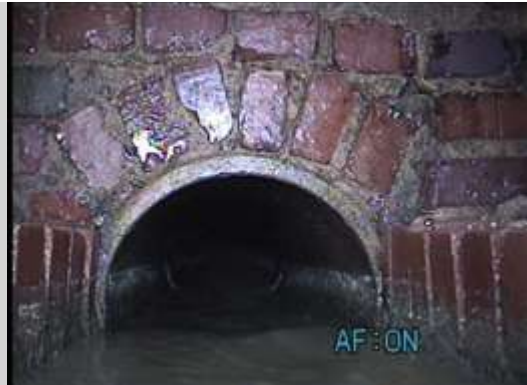
6 O'Clock Inflow

12 in. Circular Gravity Sewer

Pipe In @ 6 O'Clock

Pipe Height: **12** (in.) Rod and Bar (Angled)

Pipe Material: **Clay** ☐ Pipe Lined

Invert Depth: **11.92** (ft.) Flow Characteristics: **Fast**

Infiltration: **None** Pipe Seal Cond: **Sound**
